WADDLE RANCH WATERSHED ASSESSMENT PHASE II SUMMARY REPORT

INTEGRATED ENVIRONMENTAL
RESTORATION SERVICES, INC.

JULY 2011

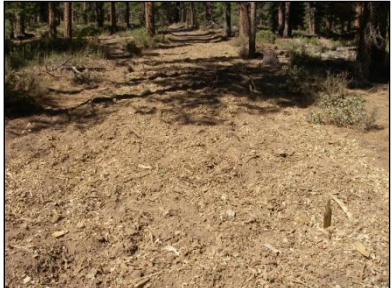
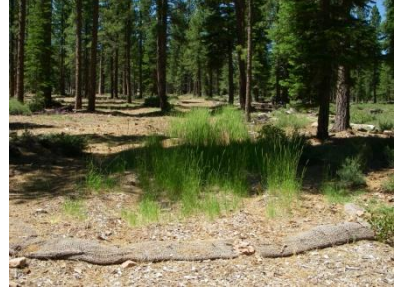
HOT SPOT	PROBLEM	TREATMENT OPTIONS	APPLICABLE TREATMENT TOOLS ¹	PHOTO 1	PHOTO 2
1	unit 3 haul road - compacted and eroding	treated by IERS in 2009 (several test plots)	1c, 1d, 2a, 2b, 2c

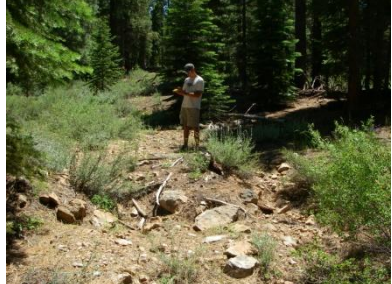
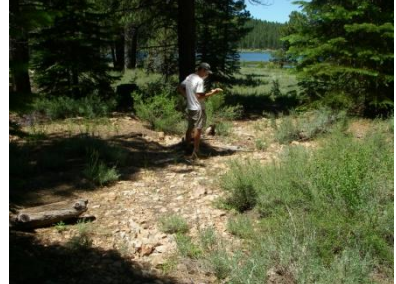
2	old abandoned road crossing ephemeral drainage from Sawmill Rd just above dry lake; small head cut caused by grade change at road crossing	remove head cut; recontour and stabilize crossing	2c, 3a

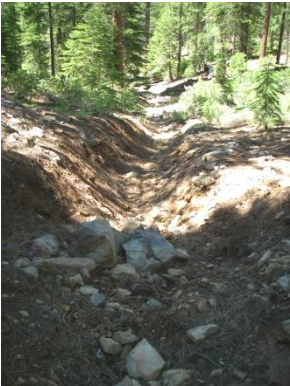
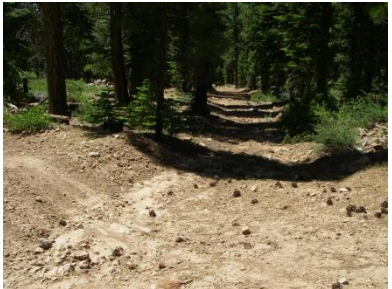
3	<p>Concentrated drainage (from heavily incised skid trail) crossing haul road above dry lake. Substantial sediment transport evident. Drainage channel crisscrosses haul road in several locations en route to Dry Lake</p>	<p>stabilize crossing(s); reroute drainage to minimize road-drainage interaction; road surfacing</p>	<p>1 (all), 2a, 2b, 2c, 3a</p>

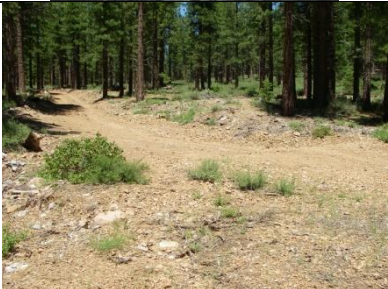
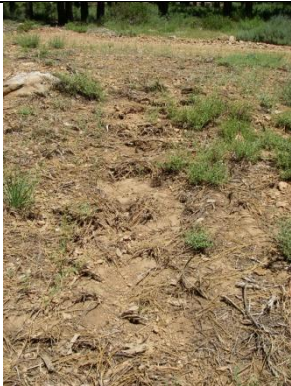
4	<p>Road drainage routed directly to ephemeral drainage via water bar. Scouring and deposition evident directly below road.</p>	<p>Manage road drainage upslope (water bars and infiltration areas, road surfacing, etc).</p>	<p>1 (all), 3a, 3b, 3c</p>

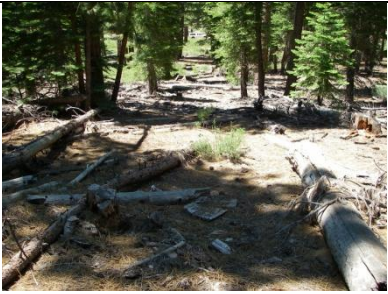
4.1	<p>Steep skid trail above HS 4. Mulch accumulation, shrub establishment, some soil development. Moderate compaction but no signs of recent erosion. Water bars in place.</p>	<p>targeted loosening (tier 2); add infiltration/sediment capture areas at water bars</p>	<p>2a, 3c</p>

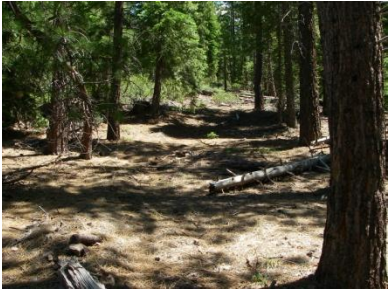
4.2	Steep skid trail above HS 4. Mulch accumulation, shrub establishment, some soil development. Moderate to high compaction but no signs of recent erosion. Water bars in place.	targeted loosening (tier 2); add infiltration/sediment capture areas at water bars	2a, 3c

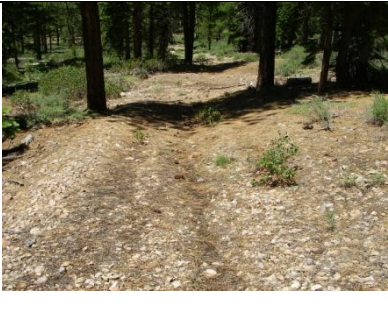
4.3	Long, steep skid trail above HS 4. Defined drainage channel down center of trail. Sediment-coated pine needles accumulated at water bar - evidence of erosion and concentrated flow. Very rocky surface.	targeted loosening (tier 2); add infiltration/sediment capture areas at water bars	2a, 3c

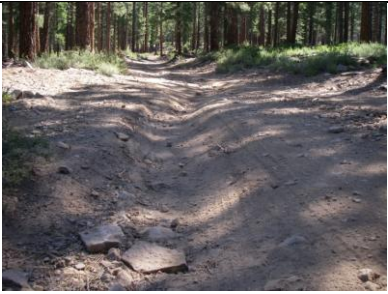
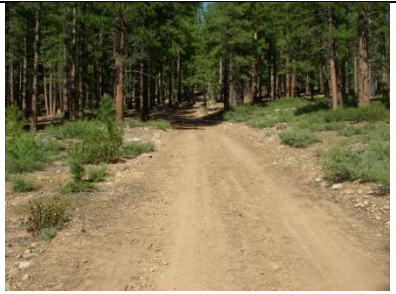
5	Gully observed on road in 2009 removed via road grading, but active erosion still present. Old skid trail intersects road just upslope of this spot - likely contributing to ongoing erosion.	Road surfacing; road drainage management (water bars, infiltration areas). Treat skid trail adjacent to roadway.	1 (all), 2a, 2b, 2c, 3b, 3c

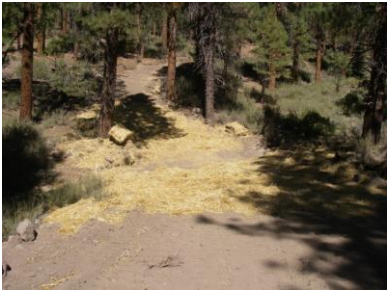
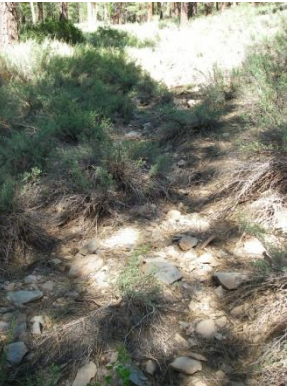
6	Haul road crossing ephemeral drainage. Steep road drains to this crossing. Evidence of high energy flows in drainage, large material deposited, scouring, etc.	Manage road drainage upslope of crossing (add infiltration areas at water bars, road surfacing, etc).	1 (all), 3b, 3c

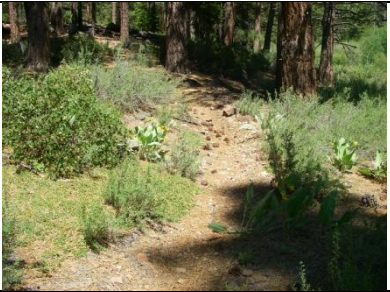
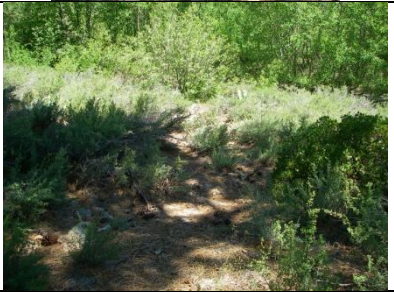
7	Dished trail coming downhill upslopes where it flattens out and runoff flows directly to East Martis Creek.	recontour trail to prevent drainage to creek; trail surfacing; infiltration areas	1b-1f, 3b, 3c

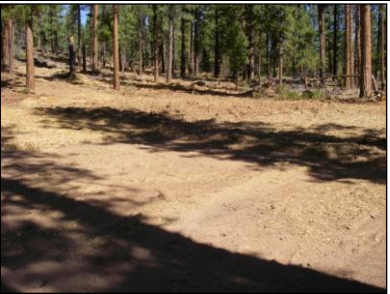
8	recently used, compacted, bare landing (unit 3 landing c)	treated by IERS in 2009 (several test plots)	2a, 2b

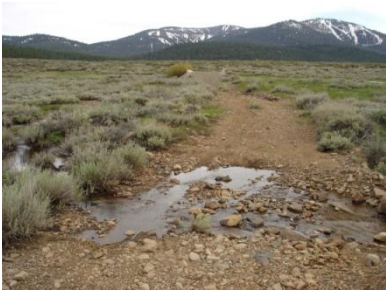
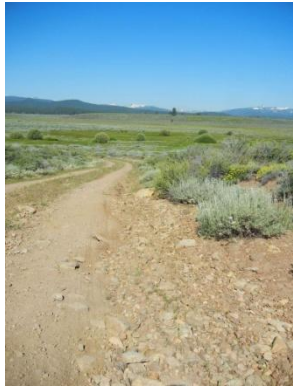
<p>9</p>	<p>unstable road-stream (ephemeral) crossing along Sawmill Rd with gullying along steep road upslope</p>	<p>Stabilize/formalize crossing; manage road drainage upslope (water bars and infiltration areas, road surfacing, etc).</p>	<p>1 (all), 3a-3d, 3f</p>

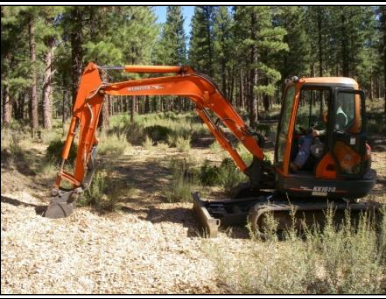
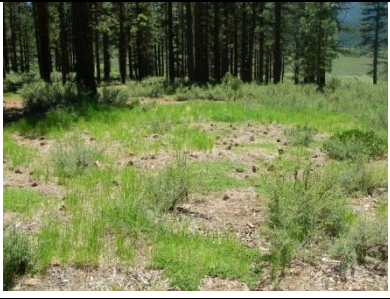
<p>11</p>	<p>recently used, compacted, bare landing (Landing A)</p>	<p>treated by IERS in 2009 (several test plots)</p>	<p>2a, 2b</p>

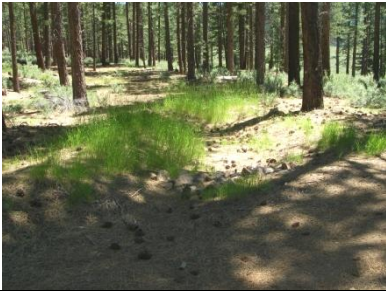
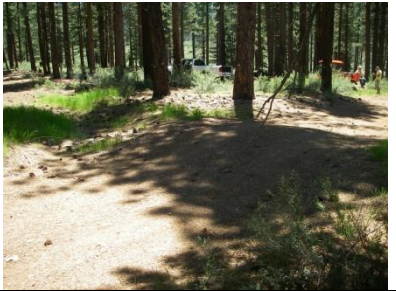
12	Concentrated road drainage causing scouring/deposition at water bar	Road infiltration test/demonstration area implemented by IERS in 2009	2b, 3b, 3c

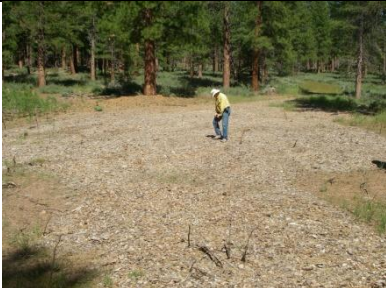
13	Recently used landing covered in wood chips. Relatively low connectivity to stream. No signs of runoff/erosion. Lower soil density than unmulched landings.	Additional mulching, targeted loosening (tier 2)	1c, 2a-2c

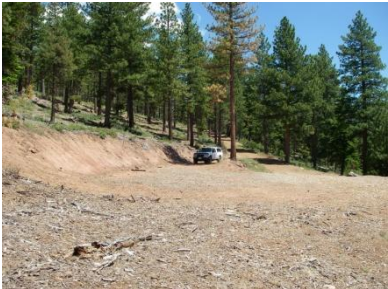
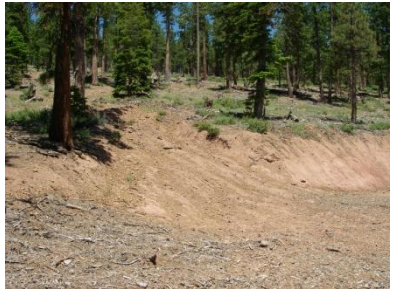
<p>16</p>	<p>Landing north of dry creek. Partial wood chip coverage. Large, heavily eroded cut slope and significant cut/fill.</p>	<p>Additional mulching and targeted loosening (tier 2); full restoration (tier 3); recontouring</p>	<p>1c, 2a-2c</p>

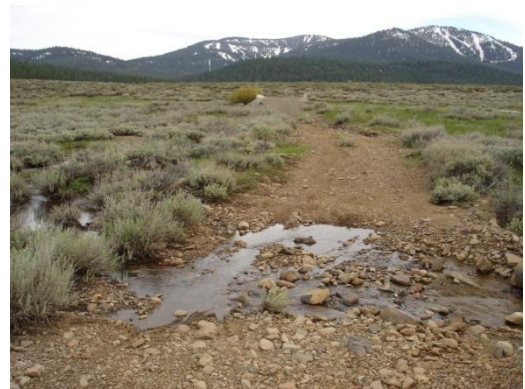
Figure 4. Historically wet meadows are now dominated by shrubs, due in part to hydrologic fragmentation caused by roads.

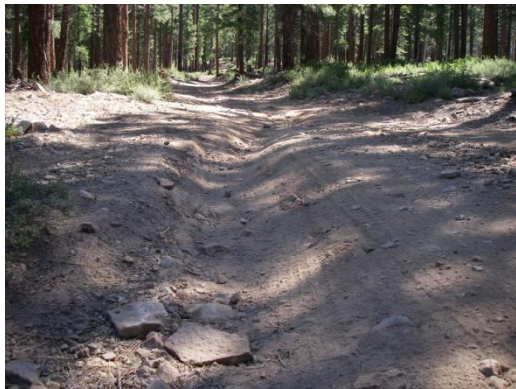
Figure 2. Water capture and gully formation on Sawmill Road.

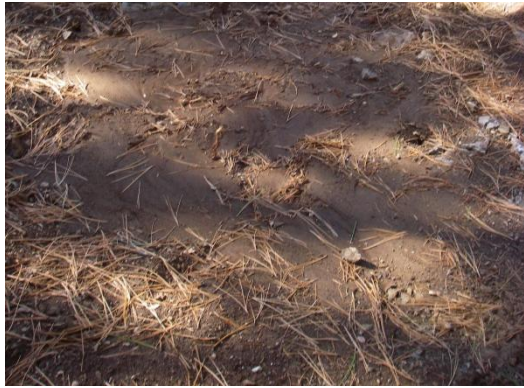
Figure 4. Sediment deposition on Sawmill Road following fall rain event.

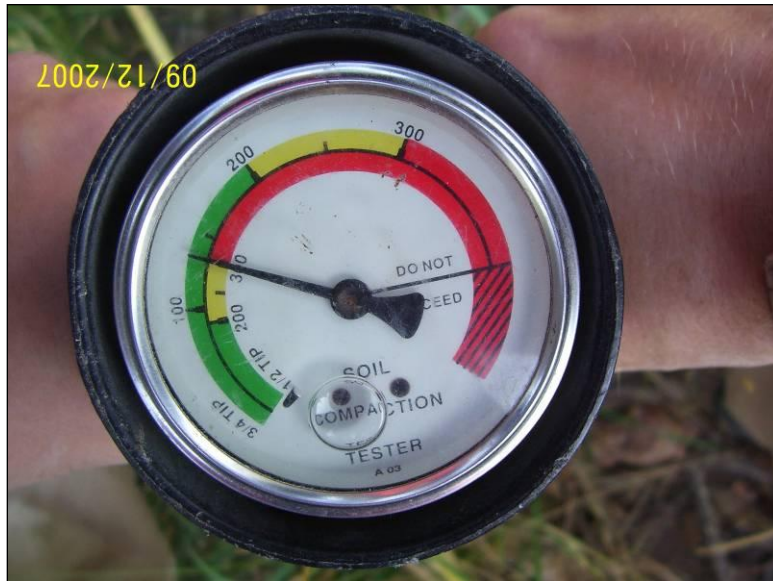
FIGURE 18. A CONE PENETROMETER DIAL, SHOWING PRESSURE APPLIED IN POUNDS PER SQUARE INCH.

Penetrometer depth to refusal and soil moisture were measured along the same transects as the cover point data for each plot. All penetrometer measurements were taken at a soil moisture of less than 6%, which is typical of the dry, summer conditions in the area. To take a measurement, the cone penetrometer with a ½ inch diameter tip is pushed straight down into the soil until a maximum pressure of 350 pounds per square inch (2,413 kPa) is reached (Figures 18 and 19). At this pressure, the depth to refusal is read.

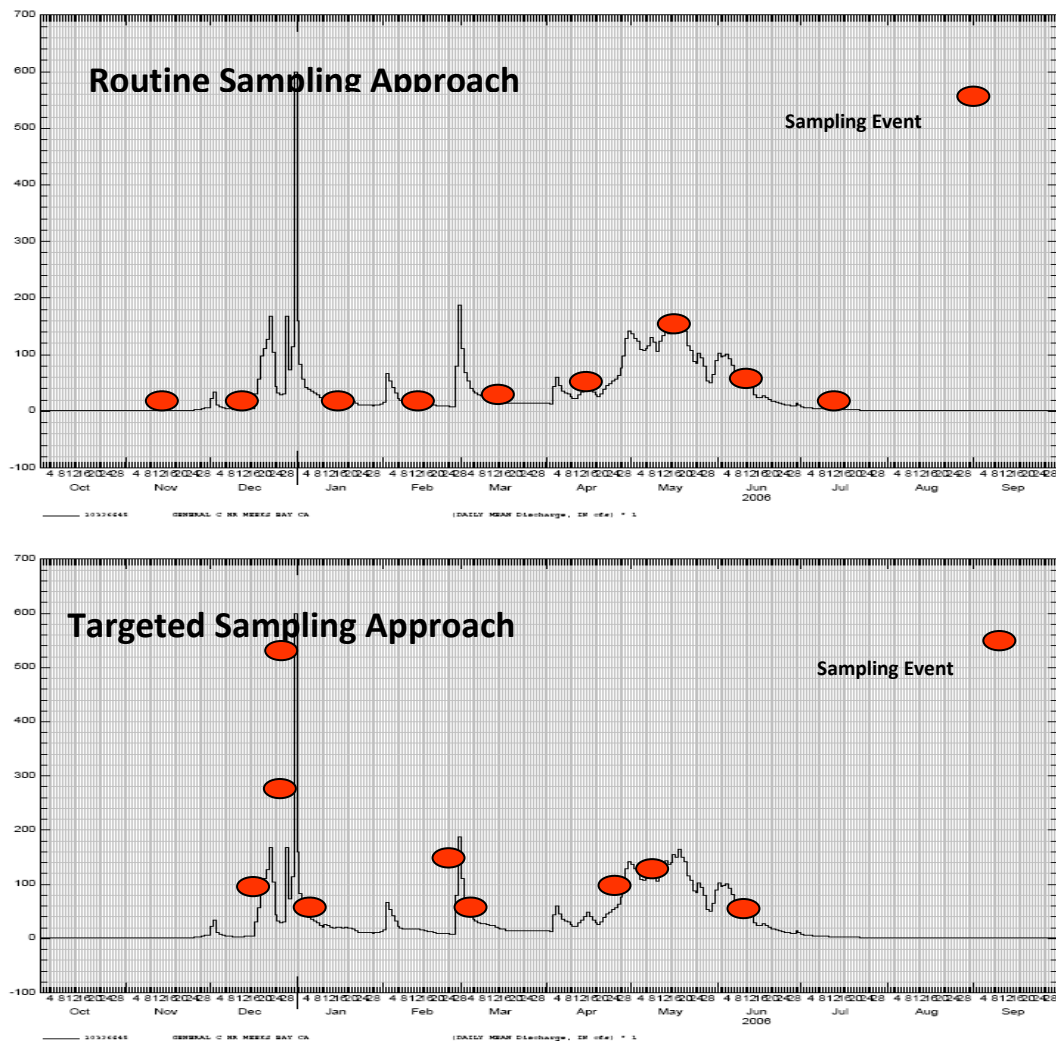
Figure 1. Example hydrographs illustrating two different sampling approaches. Routine sampling approaches (shown in top graph) typically miss spikes in stream flow and sediment concentration, limiting its usefulness for understanding sediment transport patterns in a given watershed. By clustering the same number of samples around peak flow periods (shown in bottom graph) and, most importantly, on the rising and falling limbs of daily diurnals during peak snowmelt and rain storms, sediment-discharge rating curves can be produced and used to reliably predict sediment and nutrient loads as a function of flow rate.

MoMM-type sampling can work well with point sources of pollution such as factory effluent streams that tend to be relatively consistent. However, for highly dynamic stream systems, where in-stream water quality is essentially defined by distributed, non-point sources of water and sediment, this approach does not accurately reflect rapidly changing stream and pollutant conditions. When grab samples are collected on a routine basis at a specified interval year-round, the data will poorly characterize sediment and nutrient concentrations during periods of highest concentration in streams draining small Sierra watersheds. In contrast, when the same number of samples are targeted around periods of high stream flow (e.g. peak spring snowmelt, isolated rain events), the resulting data can be used to accurately compute sediment and nutrient loading. By clustering the same number of samples around peak flow periods and, most importantly, on the rising and falling limbs of daily diurnals during peak snowmelt and rain storms, sediment-discharge rating curves can be produced and used to reliably predict

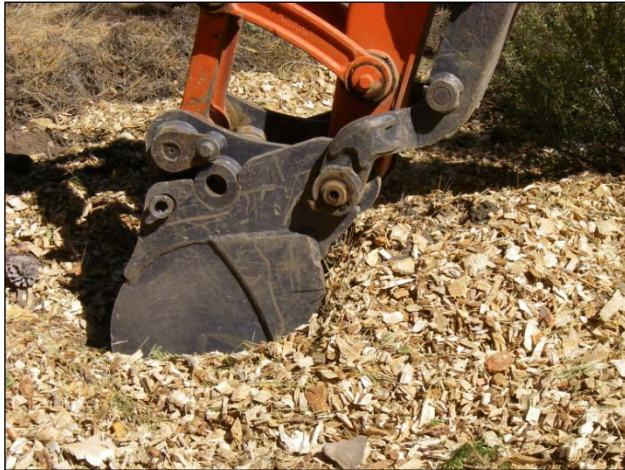
FIGURE 3. MODIFIED EXCAVATOR BUCKET AT FULL PENETRATION.

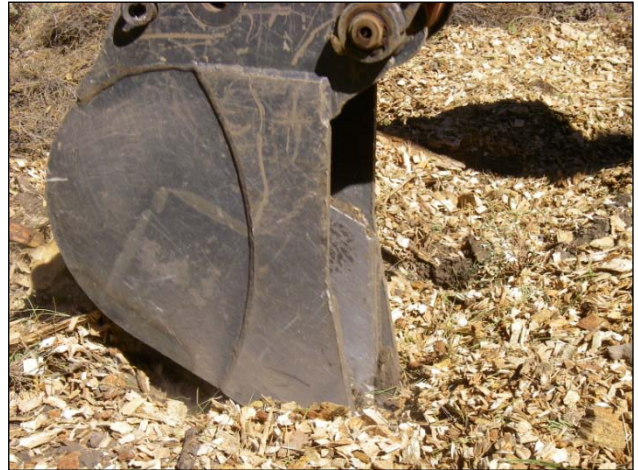
FIGURE 4. MODIFIED EXCAVATOR BUCKET RETRACTING FROM "TARGETED LOOSENING" WITHOUT TURNING SOIL.

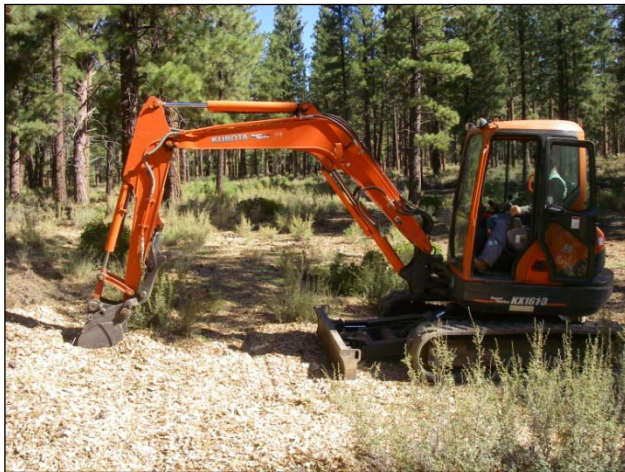
FIGURE 5. KX 161 EXCAVATOR TARGETED LOOSENING.

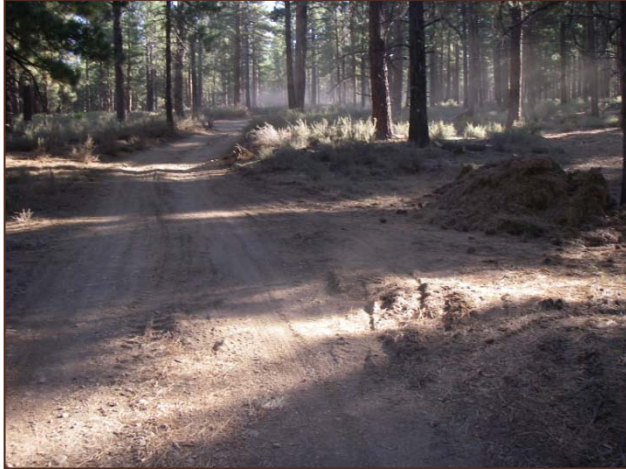
Figure 3. Rolling dip site on Sawmill Flat Road pre-construction (PPA). The basin site is on the right.

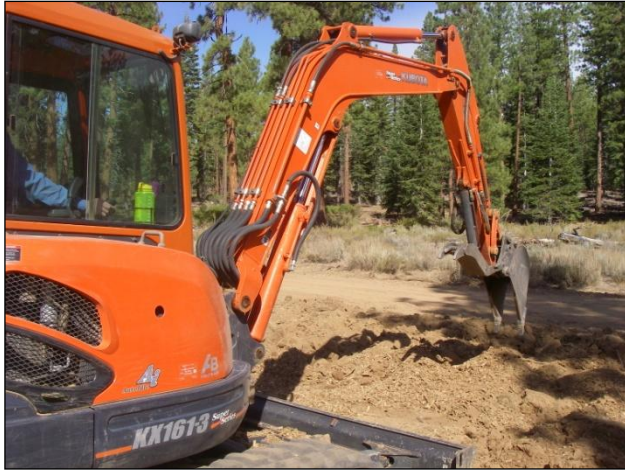
Figure 3. Ripping with a modified excavator bucket.
